## Report on the Status of the C-Mod Lower Hybrid Couplers 5/23/2005

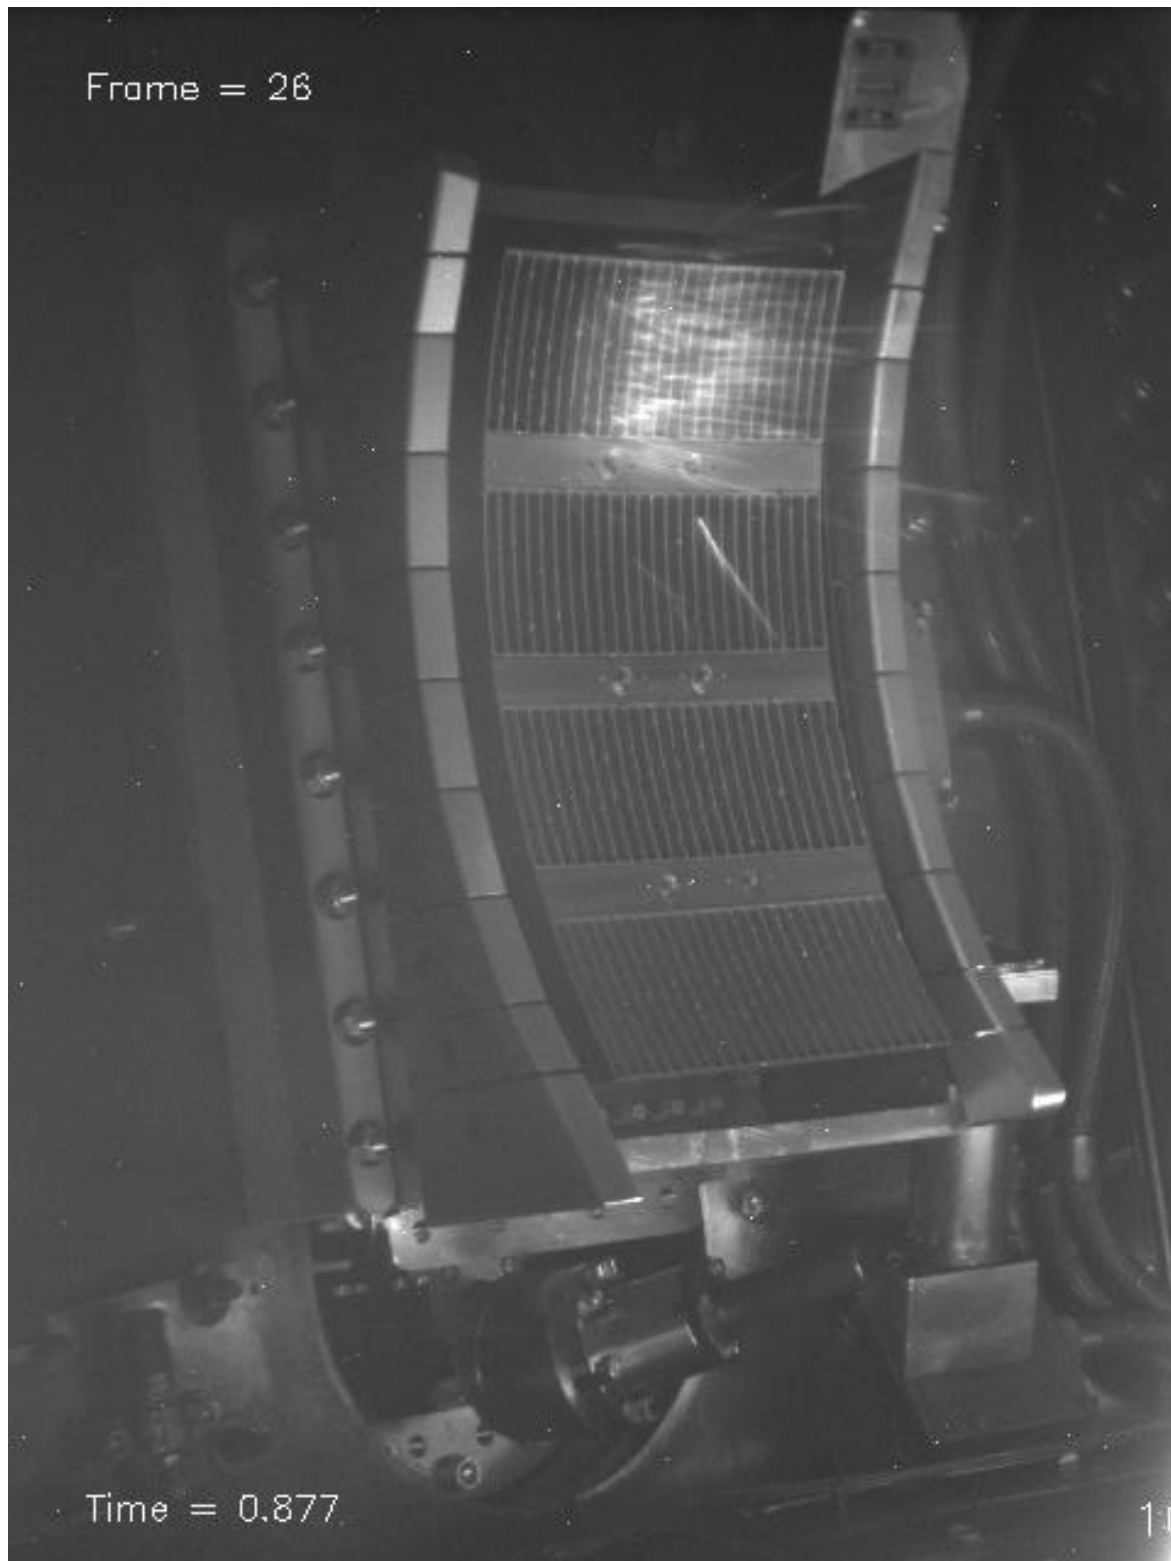
Figure 3. Injections of dust or sputtered Ti during lower hybrid conditioning

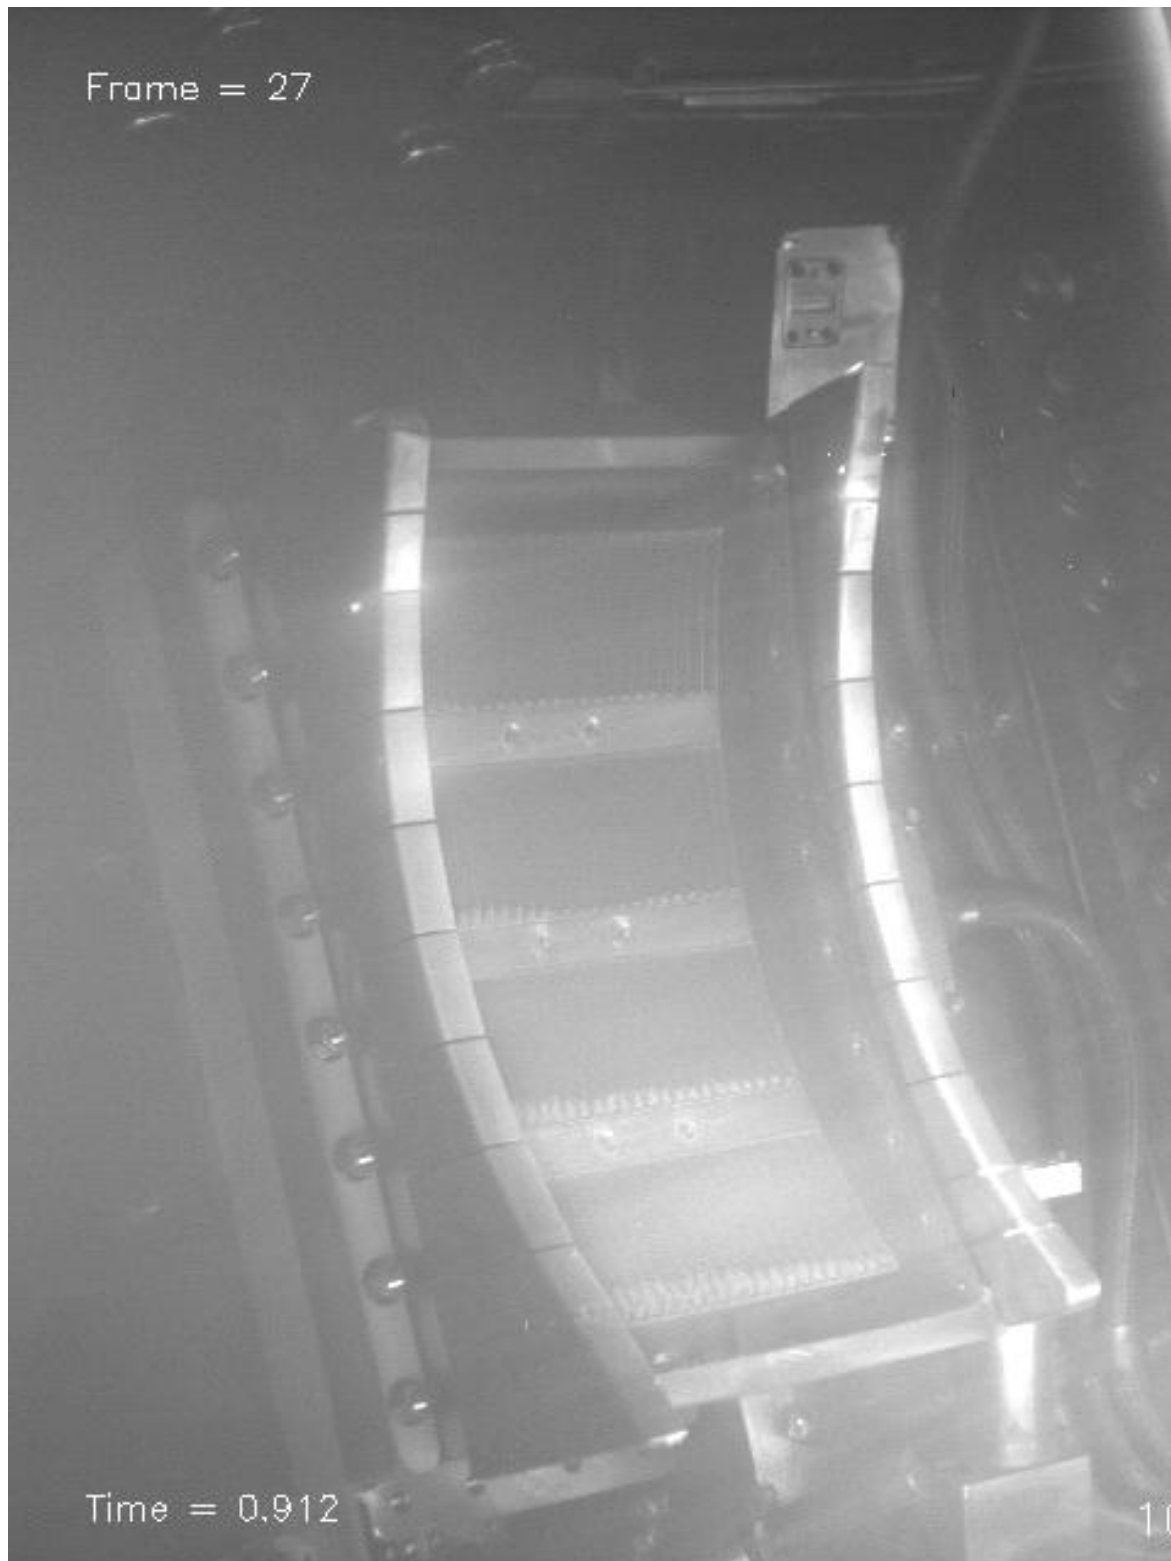
Figure 4. Debris (dust) can be seen at the bottom of the waveguide channels following the third backfill and boronization. Contrast this view to figure 3.

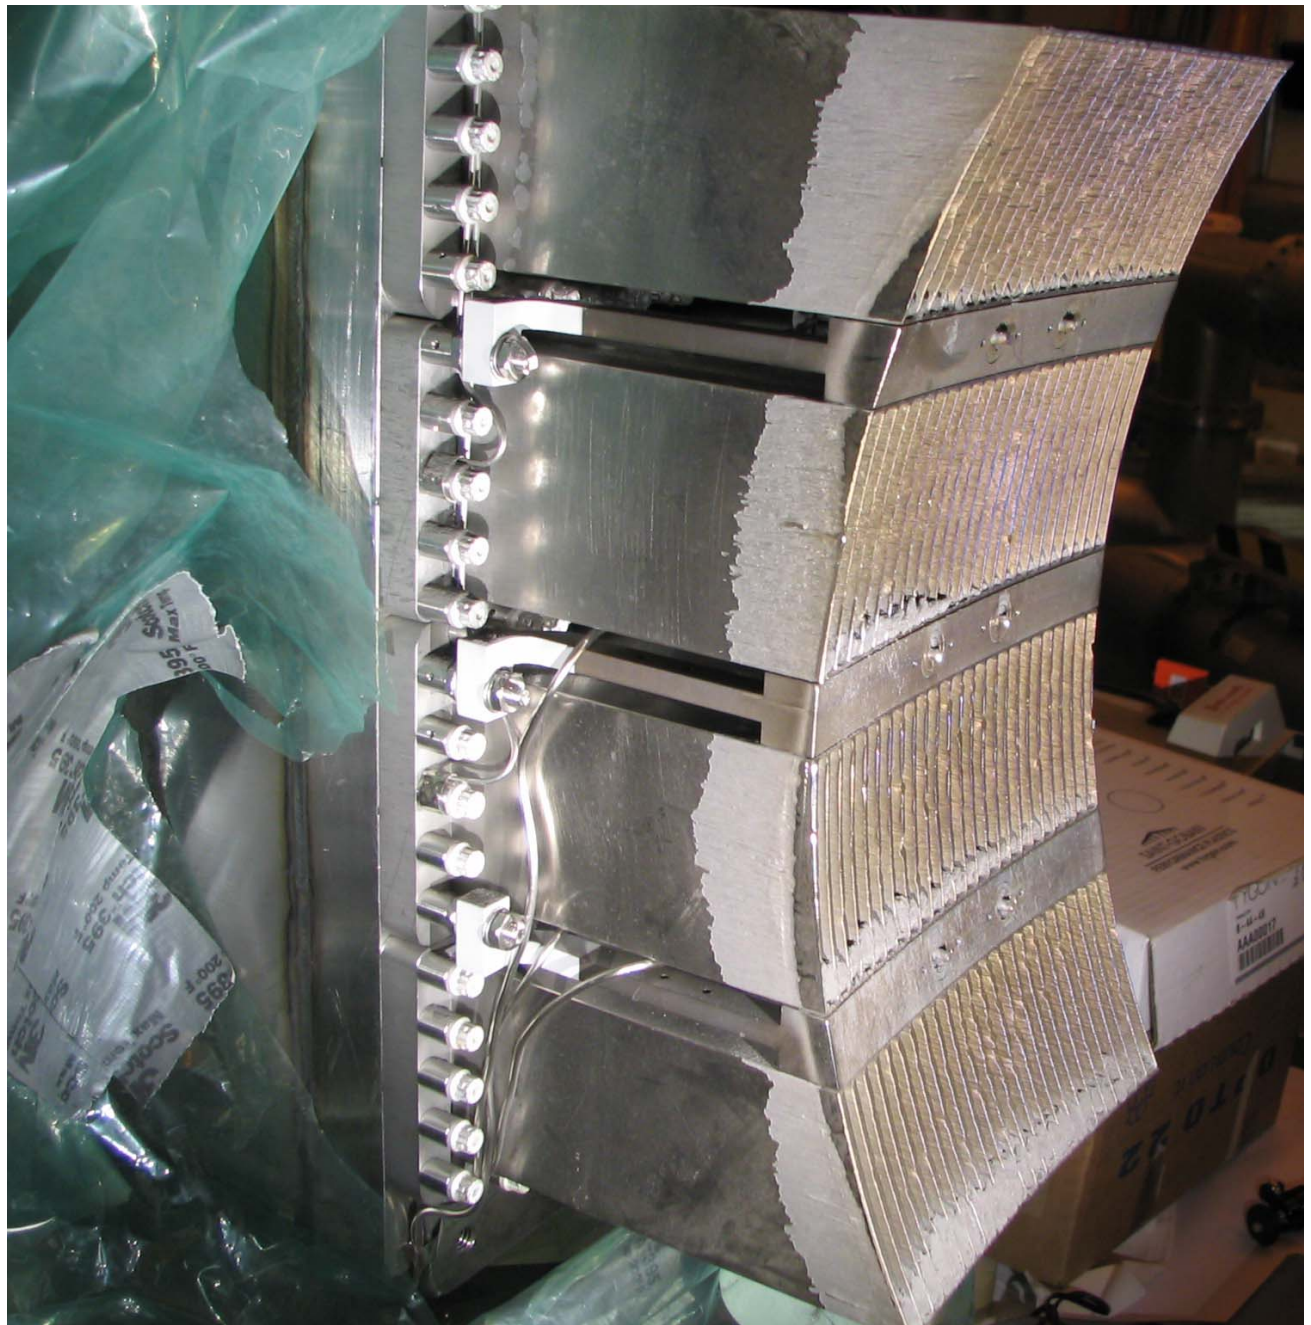
As can be seen in Figures 5 and 6, serious erosion of the coupler surfaces has been found. Erosion of the channels extended deep into the waveguide and, in some cases, dust was found piled up against the alumina vacuum windows (approximately 10 cm from the coupler face). Many grams of titanium have been eroded from the surfaces. The septa which separate the waveguide channels have been badly eroded, and in several locations, removed several millimeters back into the guide.

It is not clear what the relative contributions from the  $\text{D}_2$  backfills, boronizations, routine ECDC, or plasma operation were to the damage observed. Titanium is known to form hydrides when the oxide layers protecting the surface are removed, and the titanium is exposed to hydrogen at elevated temperature. We have done tests of the titanium alloy used in the couplers in which the sample was etched to remove the oxide, placed in vacuum, baked, and then exposed to a 500 Torr  $\text{D}_2$  backfill for 24 hours at  $60^\circ\text{C}$ . This sample showed no deleterious effects from the deuterium. However, the components in-vessel could have gone to higher temperatures in a deuterium background during plasma operation or during the boronization process. Both standard ECDC (in deuterium), which is typically run each evening following a run, and normal plasma operation could have removed the oxide layer from the titanium and made it more susceptible to the background deuterium during the Thomson scattering calibration backfills. A possible scenario is that the deuterium reacted with the titanium to form  $\text{TiD}_2$  which is less dense than the titanium base alloy and would cause spalling at the grain boundaries. The dust removed from the vessel was typically less than  $15\ \mu\text{m}$  in size, which is consistent with the grain size expected in the titanium.

Figure 5. Side view showing affected area extended well behind face of grill. Debris in waveguides can also be seen.

Though understanding the nature of the coupler damage is of interest, our primary effort is now concentrated on working with PPPL to replace the four couplers. No titanium will be allowed in the new design, and only materials that have been successfully used in C-Mod over the lifetime of the machine are being seriously considered (e.g., inconel, stainless steel). Low temperature brazes and ways to restrain the materials during brazing to limit the CTE effects are being modeled, and prototypes are being prepared. After the launcher is fitted with new couplers, it will be reinstalled into the torus.

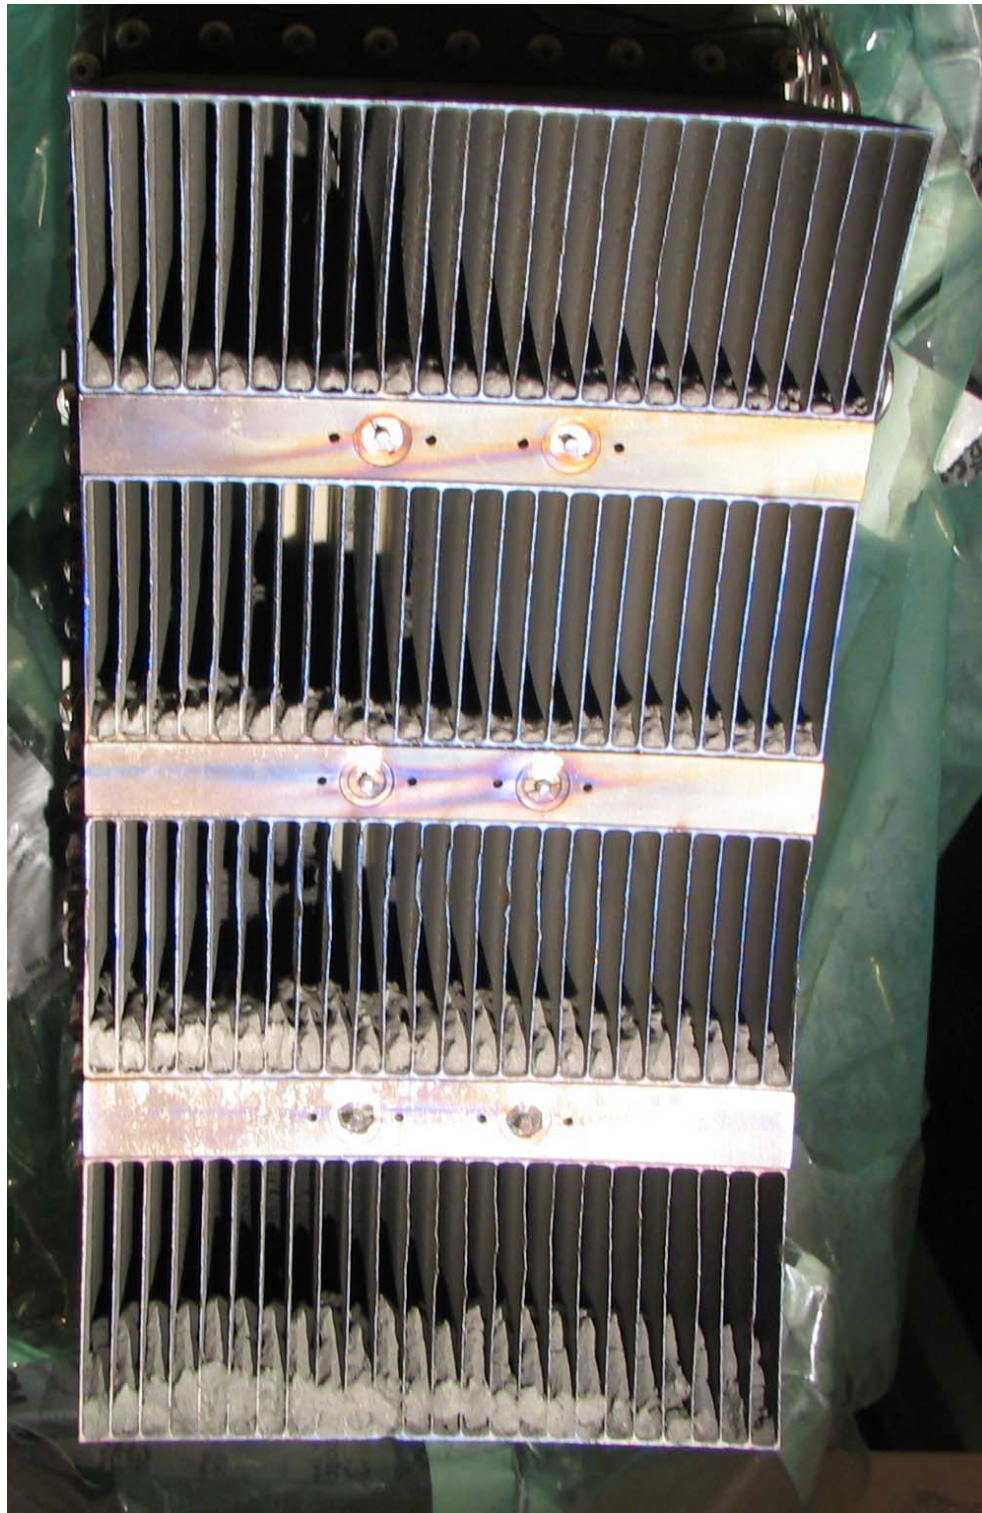
Figure 6. Front view shows debris extending well into guides. Erosion of the septum between guides clearly shown.
